**Flood Control Project Maintenance  
Levee Inspections****LMA District Cover Sheet****Spring 2013 Levee Inspection Results****Reclamation District No. 0150 Merrit Island**

**Spring 2013 Levee Inspection Results**

**Reclamation District No. 0150 Merrit Island**

Waterway			Bank	Unit Miles
Unit No. 01 Sutter Slough			Left	0.54
	Spring (March - May)	Summer (June - August)	(September - November) Fall	Winter (December - February)
Unit Maintenance Rating (Fall Only)				
Date of Inspection	03/14/2013 - 03/14/2013			
DWR Inspector	Pavel Kazi			
Accompanied By

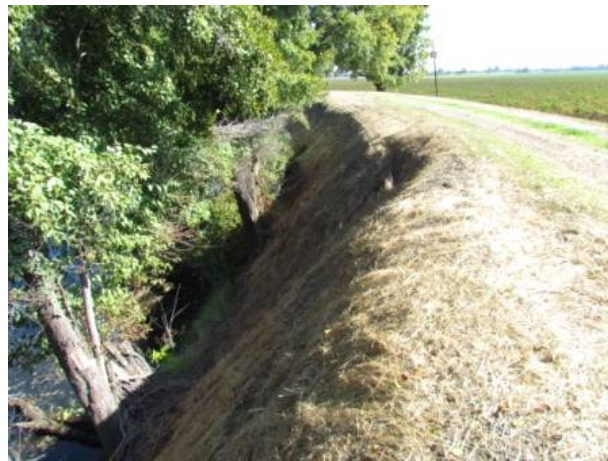
pkazi\_s\_20130304\_637.jpg

Levee Mile Report Line	91
Start Levee Mile	8.48
End Levee Mile	8.48
Location	Water Side
Category	
Item	Erosion / Bank Caving

Slope instability was found on the waterside shoulder of the levee looking upstream. This picture was taken during fall 2012 inspection.

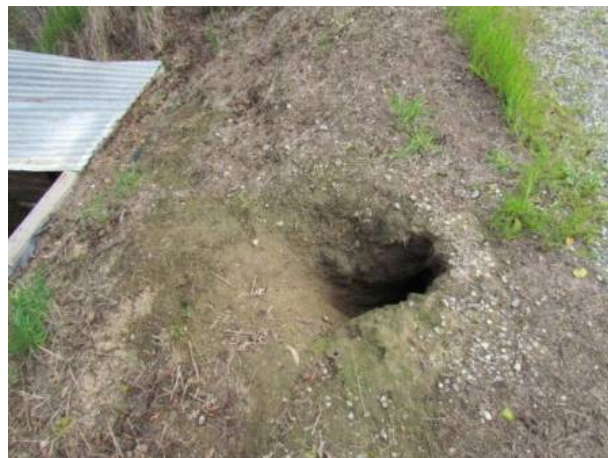
pkazi\_s\_20130304\_658.jpg

Levee Mile Report Line	92
Start Levee Mile	8.52
End Levee Mile	8.52
Location	Water Side
Category	
Item	Animal Control

A rodent hole was found on the waterside of the levee looking upstream.

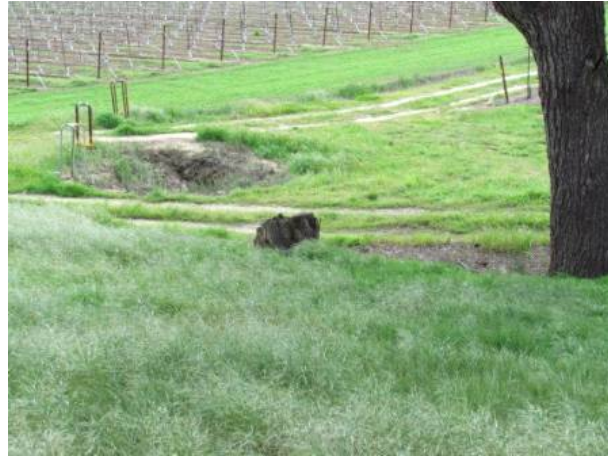
Levee Mile Report Line	95
Start Levee Mile	8.62
End Levee Mile	8.62
Location	Land Side
Category	
Item	Trim / Thin Trees
A tree stump was found on the landside of the levee looking upstream.	
pkazi_s_20130304_659.jpg

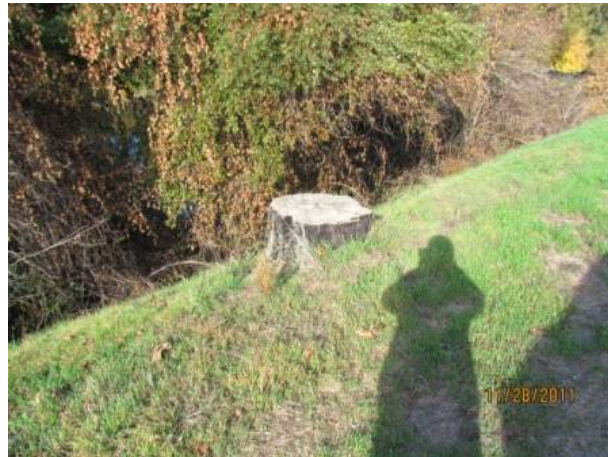
Levee Mile Report Line	96
Start Levee Mile	8.65
End Levee Mile	8.65
Location	Water Side
Category	
Item	Trim / Thin Trees
A tree stump was found on the waterside of the levee looking upstream.	
pkazi_s_20130304_621.jpg

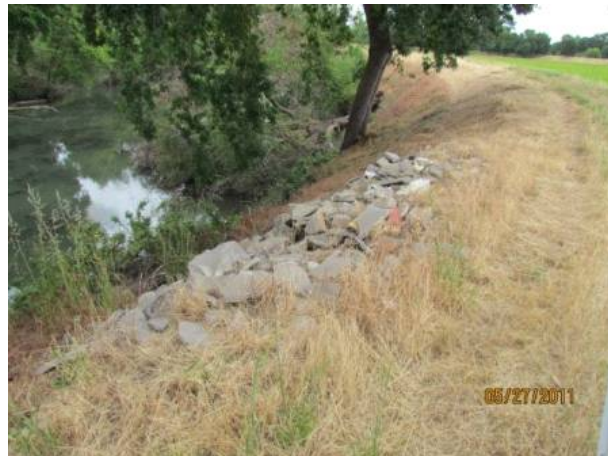
Levee Mile Report Line	97
Start Levee Mile	8.87
End Levee Mile	8.87
Location	Water Side
Category	
Item	Encroachments
Broken concrete pipe was left on the waterside slope of the levee. The picture was taken from the crown looking upstream.	
pkazi_s_20130304_580.jpg

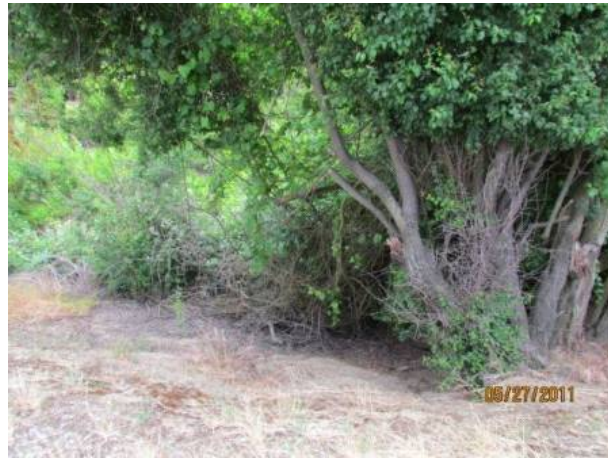
pkazi\_s\_20130304\_642.jpg

Trees needed to be trimmed for visibility of the waterside slope of the levee. The picture was taken from the crown looking towards the slough.

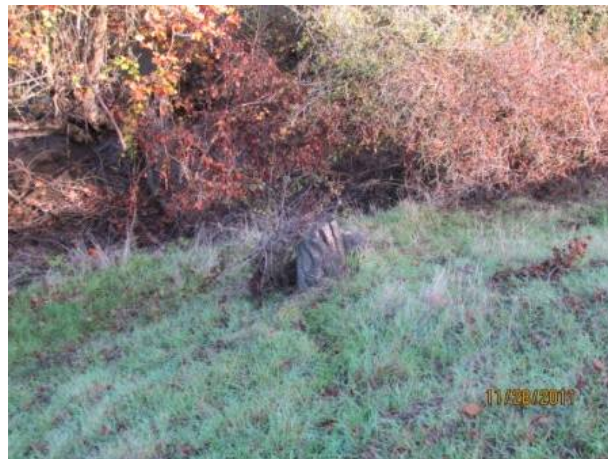
pkazi\_s\_20130304\_625.jpg

Levee Mile Report Line	99
Start Levee Mile	9.38
End Levee Mile	9.38
Location	Water Side
Category	
Item	Trim / Thin Trees

A tree stump was found on the waterside of the levee looking upstream.

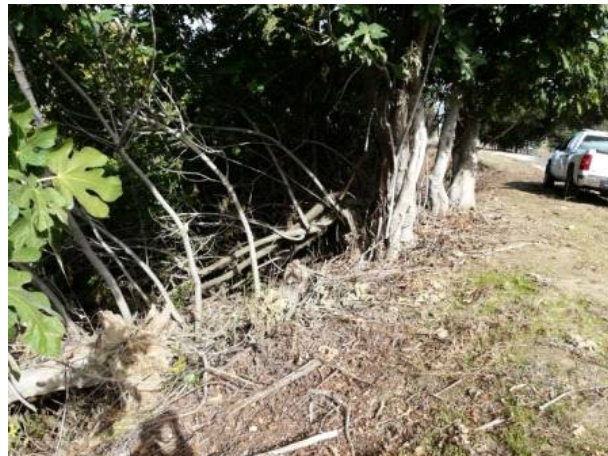
pkazi\_s\_20130304\_643.JPG

Levee Mile Report Line	100
Start Levee Mile	9.51
End Levee Mile	9.51
Location	Water Side
Category	
Item	Trim / Thin Trees

Thin/trim trees to allow for visibility of top 20' of waterward slope at LM 9.51.

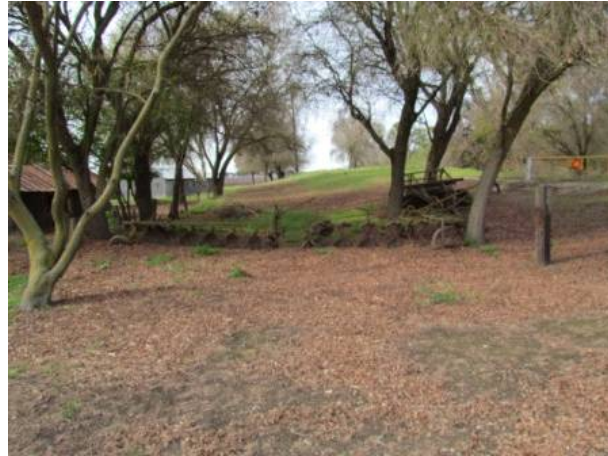
pkazi\_s\_20130304\_672.jpg

Equipment was found on the landside of the levee looking downstream.
